## ***Broken Brakes:*** **Answers to Some Parking-Brake Problems**

***Bolt-on parking-brake assembly on some ZF manual transmissions requires careful handling.***

**By Mike Weinberg**  
**Contributing Editor**

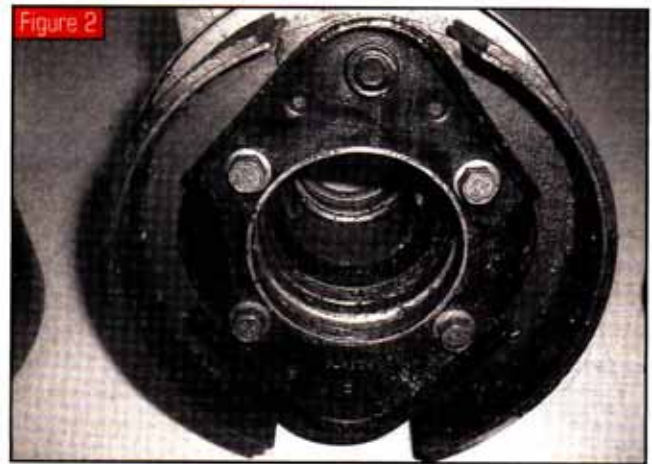
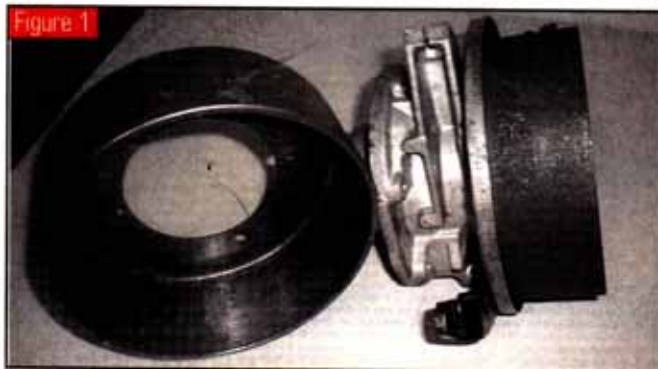
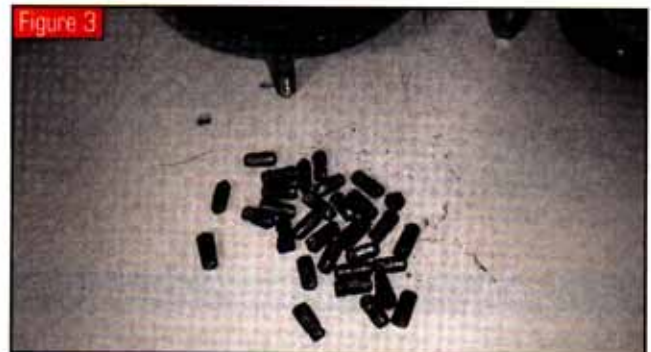
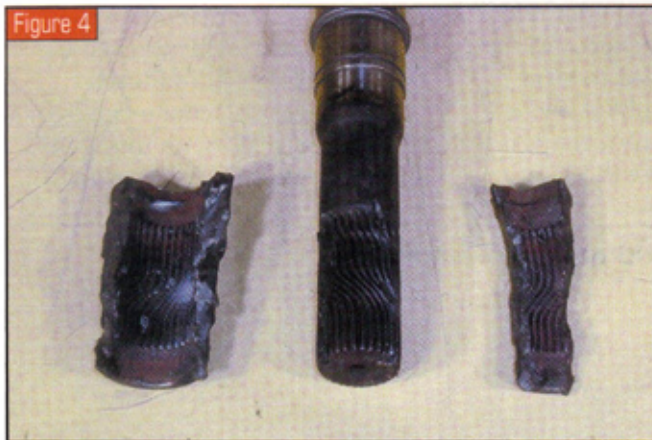
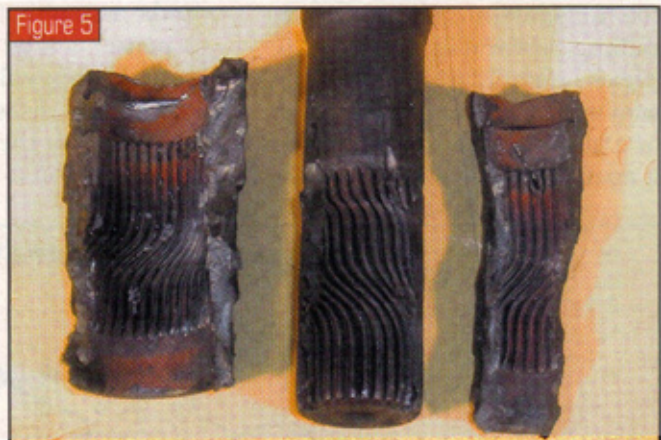
Careless handling of these assemblies can create some expensive and time-consuming comebacks. If the unit is filled with fluid and tipped over or turned upside down, the fluid will leak from the vent and contaminate the lining of the brake shoes, ruining them. If the brake assembly is installed without fluid or with insufficient fluid, the internal bearings and seals will fail in short order. Photos 1 through 5 show an assembly that was brand new and installed by the purchasing shop

without being filled with oil. This damage occurred within one mile of driving, and the manufacturer would not honor the warranty on the unit because it was not filled with lubricant as specified.

Because of the extreme heat generated by the dry bearings in the assembly, the splines on the

output shaft of the transmission often will twist under the driving load. This also will make the matching splines on the mainshaft of the parking-brake assembly twist in a corresponding pattern. As a result, the brake assembly is now impossible to remove from

the transmission. No amount of pulling power will separate the brake assembly from the transmission output shaft, and only a torch or a plasma cutter will work to get it apart. This means that a new

brake assembly (at considerable expense) will be required and the transmission will need to be removed and disassembled for replacement of the output shaft. It is very common to have these units

sure to handle the unit with care so it will not fall over and lose the fluid. After doing the clutch job, make sure to check the fluid in the transmission and the parking-brake assembly once it is installed before test driving.

When separating a brake assembly from the transmission to repair the transmission, make sure to keep the brake assembly upright so as not to damage the brake shoes, and check the fluid again in the brake assembly after re-installing it on the transmission and putting the transmission back in the truck.

When a customer comes in for service and a fluid change, be sure to check the brake assembly for proper lubrication level as part of the service. The only way to handle one of these parking-brake assemblies safely is to install it on the transmission before you add fluid and make sure the complete assembly does not fall over while you're installing it into the vehicle.

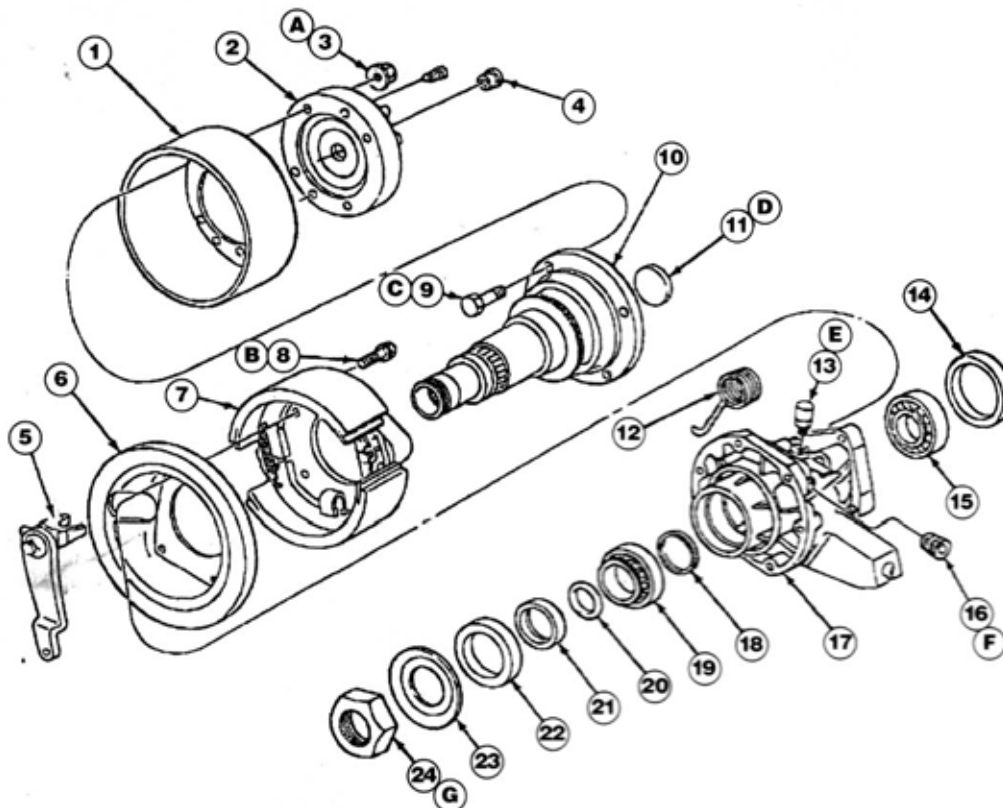
## Transmission-Mounted Parking-Brake Assembly

Item	Part Number	Description
1	-	Parking-brake drum (Part of 2C598)
2	-	Output flange (Part of 2C598)
3	2L611	Mainshaft-to-output-flange nut
4	2L610	Output-flange plug
5	2A710	Actuating lever
6	2A703	Splash shield
7	2L598	Parking-brake shoe and backing-plate assembly
8	2L818	Backing-plate-to-housing bolt
9	2L617	Mainshaft-to-output-flange bolt
10	-	Mainshaft (Part of 2C598)
11	-	Parking-brake seal disc (Part of 2C598)
12	2M598	Actuating-lever spring
13	2L605	Parking-brake vent
14	2L606	Parking-brake rear seal
15	2L603	Parking-brake rear bearing

Item	Part Number	Description
16	2L608	Parking-brake filler plug
17	2K598	Parking-brake housing
18	2L613	Mainshaft shim
19	2L602	Parking-brake front bearing
20	7288	O-ring
21	2L601	Mainshaft spacer
22	2L607	Parking-brake front seal
23	-	Lock-nut washer (part of 2598)
24	2L616	Lock nut
A	-	Tighten to 113-117 Nm (84-88 lb.-ft.)
B	-	Tighten to 118-123 Nm (87-90 lb.-ft.)
C	-	Unless damaged, leave bolt in mainshaft
D	-	Unless damaged, leave seal disc in mainshaft
E	-	Tighten to 11-16 Nm (8-12 lb.-ft.)
F	-	Tighten to 35-40 Nm (26-29 lb.-ft.)
G	-	Use new lock nut and tighten to 288-292 Nm (213-215 lb.-ft.)

The exploded views of the parking-brake assembly and the parts legends included in this article should help you better understand the internal working of this simple but expensive part. **TD**
